Dredging Gets Green

A small site and a difficult location were among the challenges faced during this unusual project to dredge an irrigation pond at a Finnish horticultural college

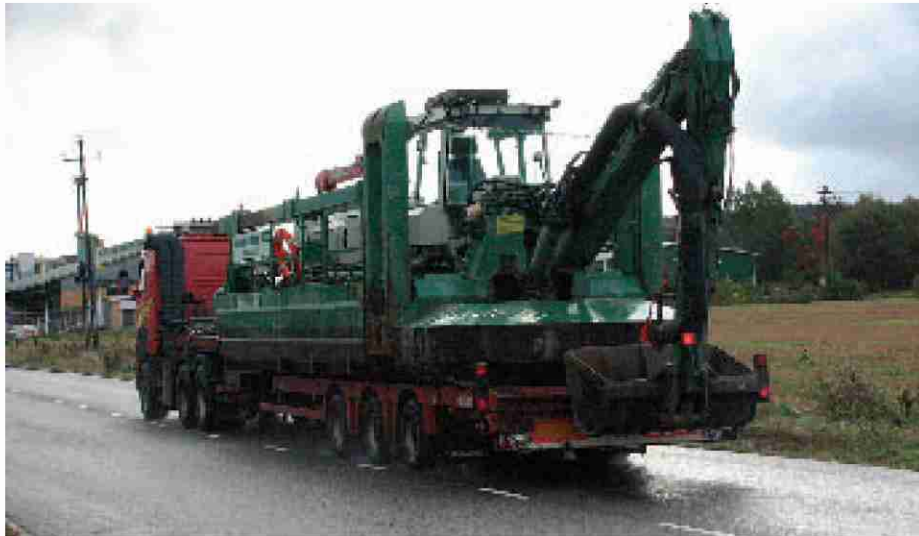
▲ *Watermaster arrives on-site...*

Watermaster was initially detached from its trailer and manoeuvred into a position on the bank, where operator Sami Ojanen switched its backhoe bucket attachment with a cutter suction pump, then 'walked' the vessel into the pond. *Watermaster* was next brought close to the settlement pool and a pipeline attached to pump sediment mixture from the pond into the pool.

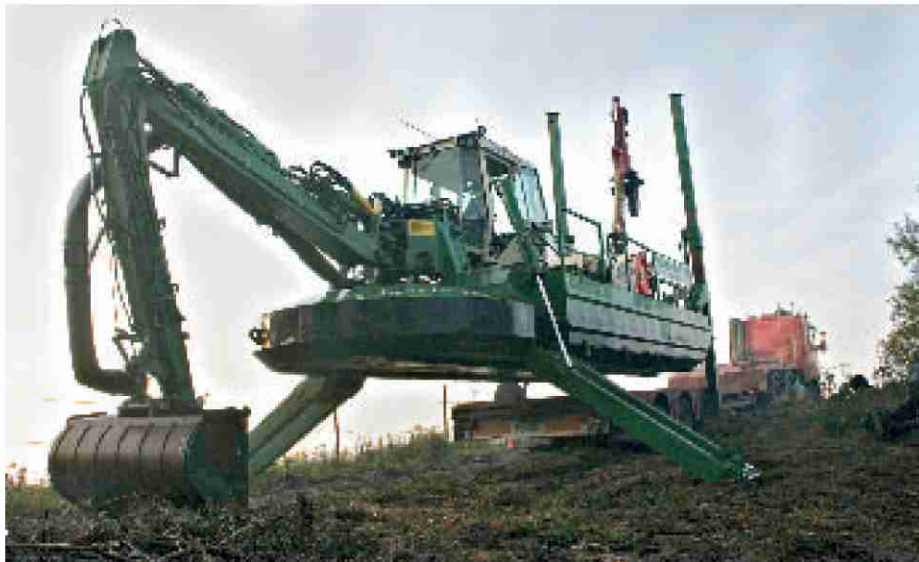
▲ *...is detached from its trailer and...*

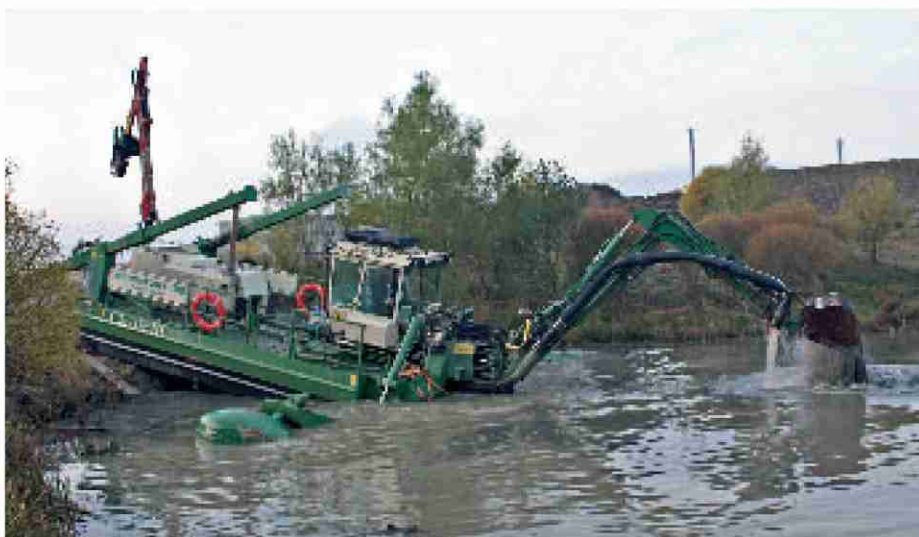
▲ *...'walks' into the pond*

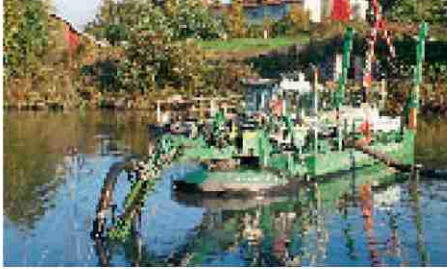
▲ *Work begins with Sami Ojanen at the helm*

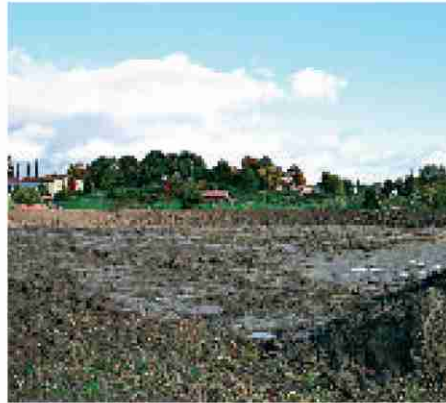
▲ *Settlement pool before and...*

After careful planning, the project began with construction of a temporary settlement pool where dredged material could be pumped and clean water allowed to drain back into the pond. The depth and condition of the pond and its bottom were then assessed to determine the amount of dredging required, which both client and operator eventually agreed would have to take the pond down to an average 2.5m.

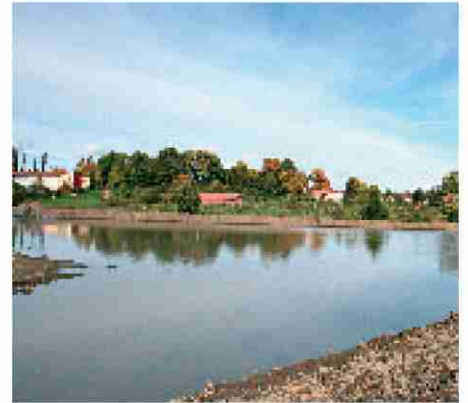
▲ *...after dredging*
